Sony VAIO PCG-3E2L Hard Drive Replacement

The purpose of this guide is to help the reader replace the Hard Drive of the device.

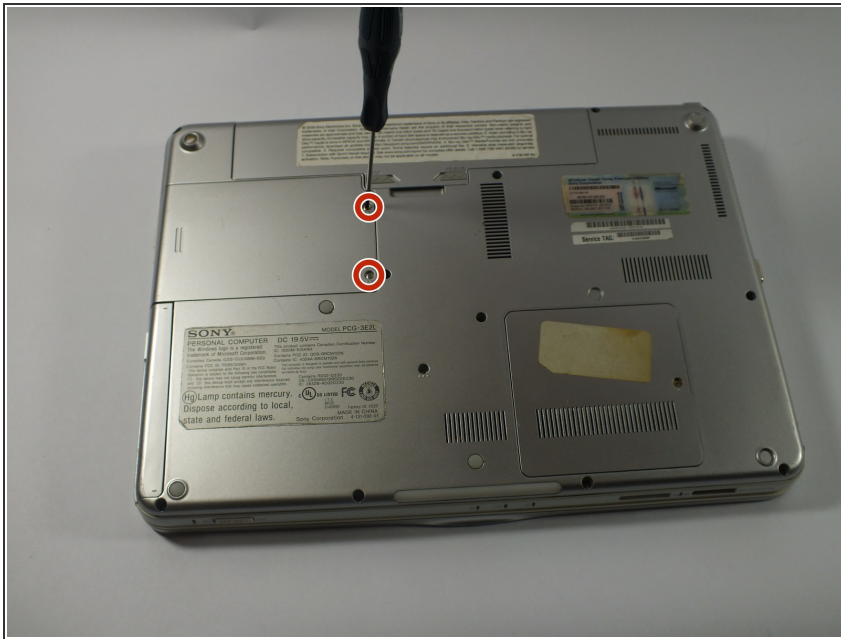
Step 1 — Hard Drive

- Using a #00 Phillips screwdriver, remove the screw

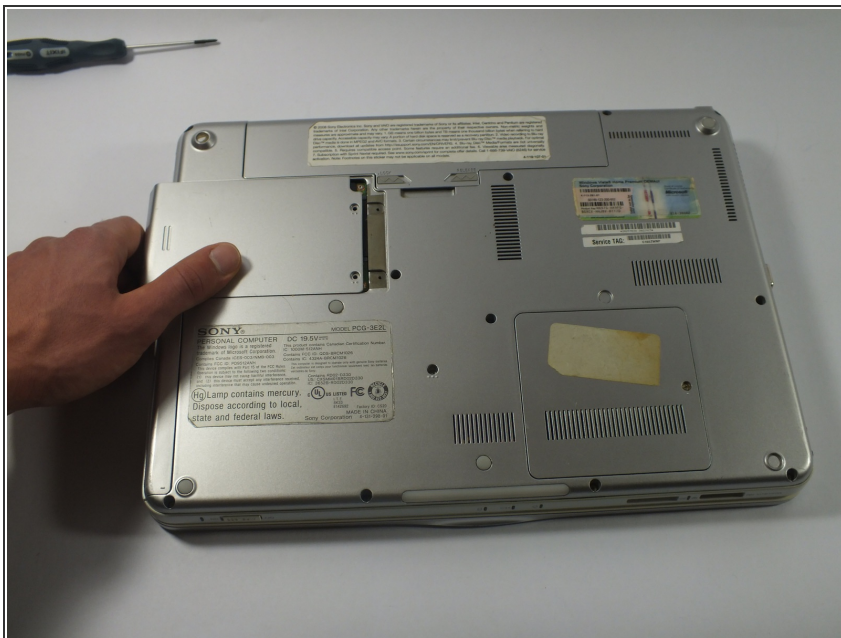
Step 2

- Remove the cover

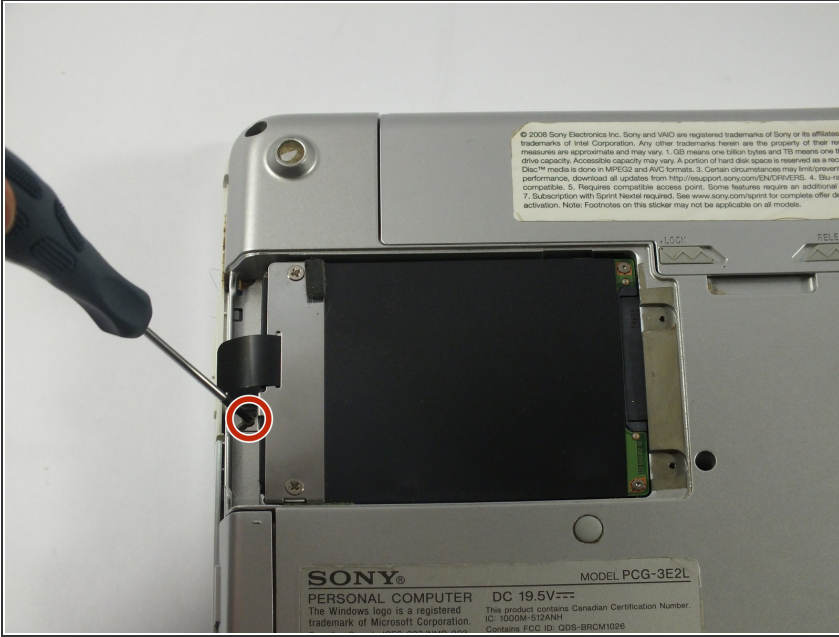
Step 3

- Using a #00 Phillips screwdriver, remove the screw

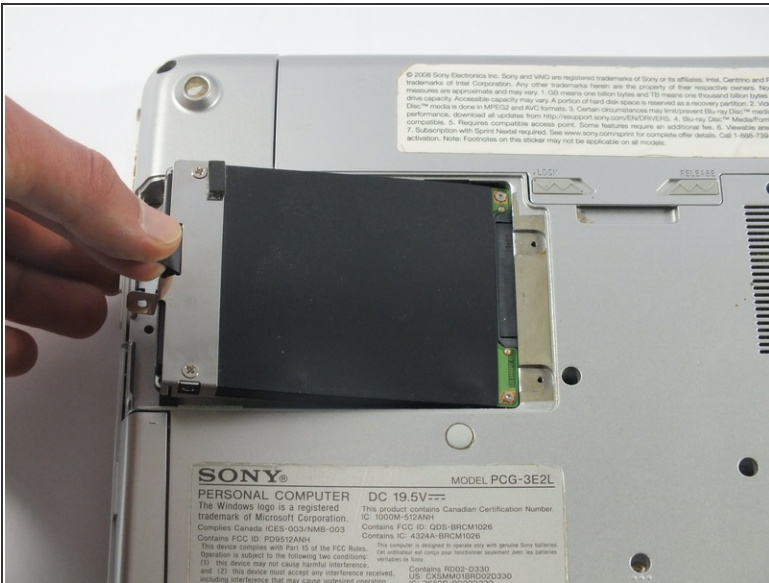
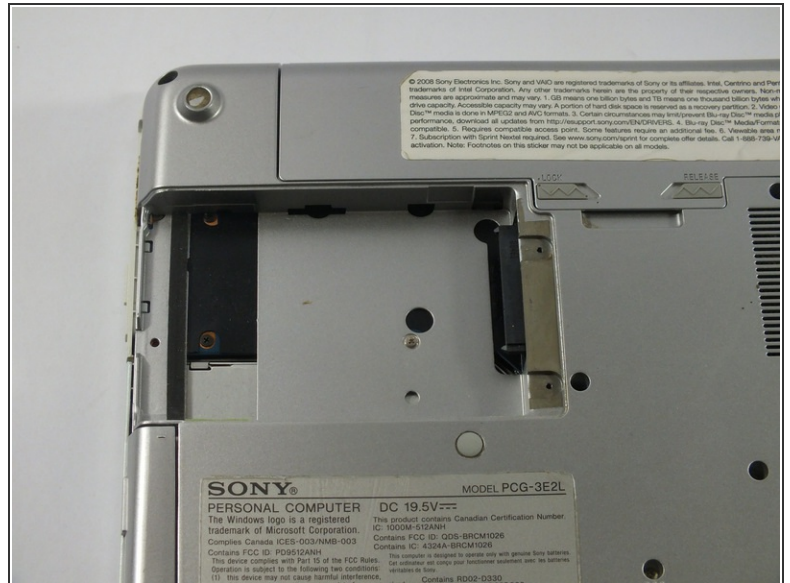
Step 4

- Grab the black plastic handle and pull the hard drive out slowly.

⚠ Only pull the hard drive horizontally. Do not lift the hard drive vertically
